DEPARTMENT OF TRANSPORTATION

Quality Assurance and Source Inspection

Contract #: 04-0120F4Cty: SF/ALA Rte: 80 PM: 13.2/13.9File #: 69.28**WELDING INSPECTION REPORT****Resident Engineer:** Pursell, Gary**Address:** 333 Burma Road**City:** Oakland, CA 94607**Report No:** WIR-006839**Date Inspected:** 23-May-2009**Project Name:** SAS Superstructure**OSM Arrival Time:** 700**Prime Contractor:** American Bridge/Fluor Enterprises, a JV**OSM Departure Time:** 1900**Contractor:** Zhenhua Port Machinery Company, Ltd (ZPMC), Changxing Island **Location:** Shanghai, China**CWI Name:** Chen Xi**CWI Present:** Yes No**Inspected CWI report:** Yes No N/A**Rod Oven in Use:** Yes No N/A**Electrode to specification:** Yes No N/A**Weld Procedures Followed:** Yes No N/A**Qualified Welders:** Yes No N/A**Verified Joint Fit-up:** Yes No N/A**Approved Drawings:** Yes No N/A**Approved WPS:** Yes No N/A**Delayed / Cancelled:** Yes No N/A**Bridge No:** 34-0006**Component:** OBG crossbeams**Summary of Items Observed:**

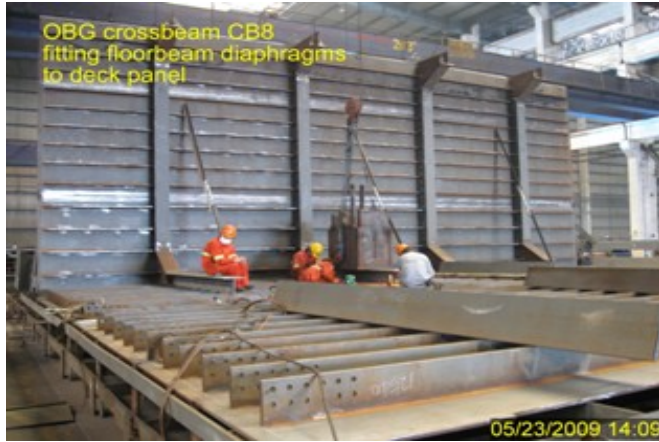
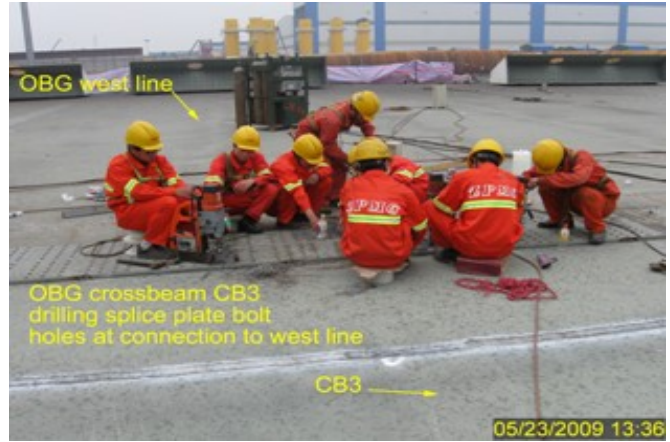
This QA observed ZPMC personnel installing side panel stiffener splice plates. This QA performed random Visual Testing (VT) of the fillet welds joining the floorbeam diaphragm to the FL3's. QA found and marked numerous areas of undercut and overlap on these welds. QA informed ZPMC QA identified as Mr. Shen Xuejun of this and requested that ZPMC's Certified Welding Inspector (CWI) re examine these welds. Mr. Shen said he would have QC look at these welds and would inform this QA when the welds were ready for QA testing.
